# Migration of a Broken Drill Bit After Acetabular Fracture Fixation. A Case Report

## ABSTRACT

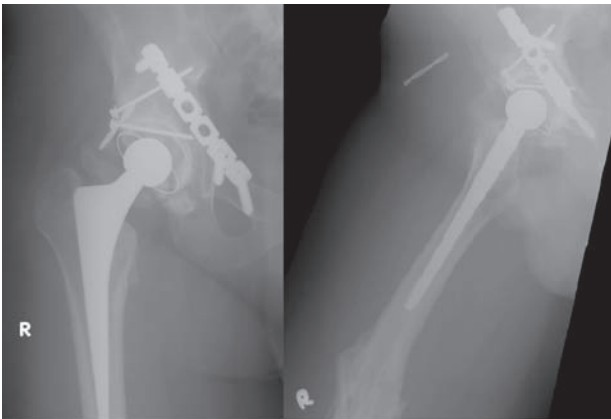
On physical examination, the right groin appeared swollen with a sharp tip palpable over the swelling. It was extremely tender to touch. Lateral plain radiograph showed migration of the broken drill bit to the subcutaneous tissue anterior to the right hip joint. (Figure 3)

**Fig. 3:** Plain radiographs show migration of a broken drill bit to the posterolateral aspect of the right hip (September 2010).

We suspected that this migrated broken drill bit was causing the groin pain and decided to surgically remove the hardware immediately. In the present case, a broken drill bit migrated to the subcutaneous tissue anterior to the acetabulum and could have caused injury to the adjacent femoral nerve or blood vessels. We informed the patient about potential complications if the hardware was not removed and also risks during the surgery to remove it.

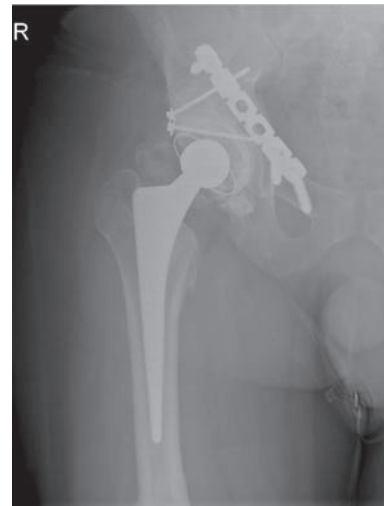
**Fig. 4:** Plain radiographs after removal of a broken drill bit.

We removed the hardware quite easily under local anaesthetic because it was quite superficial. Postoperative recovery was uneventful, and the pain and swelling then resolved completely.
