An Unusual Case of “Locking” of the Knee Four Years Post Fixation of an Open Supracondylar Femur Fracture

Yuet Peng Khor, MRCS (Ed), Diarmuid Murphy, FRCS

University Orthopaedics, Hand & Reconstructive Microsurgery Cluster, National University Hospital, Singapore

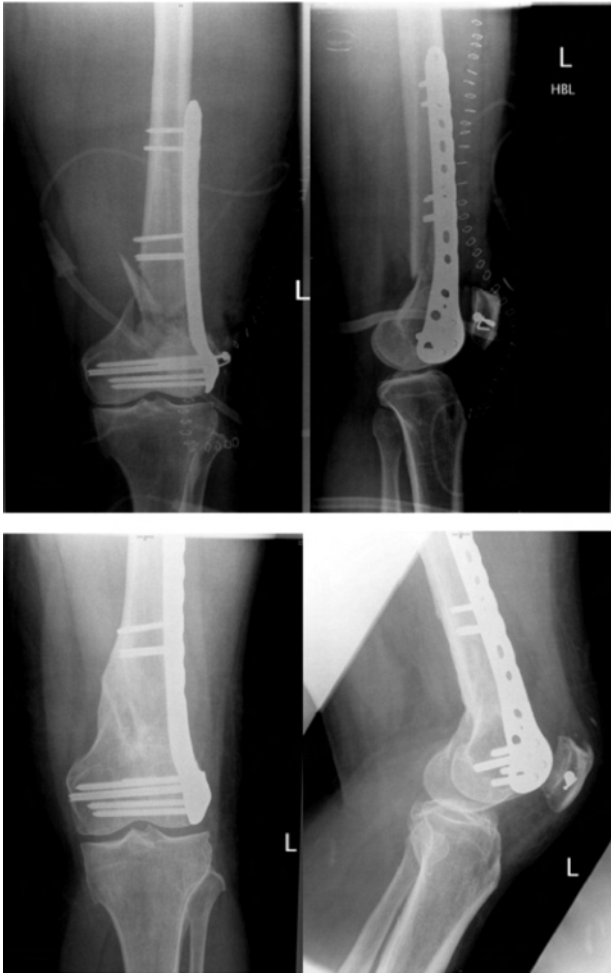
Fig. 1: Immediate post operative anteroposterior and lateral radiographs of the knee (a) and at seven months postoperatively showing complete union (b)

A 42-year-old man was admitted in 2008 following a road traffic accident in which he was a motorcyclist hit by a car. He sustained a Gustillo IIIA AO Type 33C3 left supracondylar femur fracture and a vertical-split fracture of his patella. He underwent surgery for fixation of the supracondylar fracture with a 10 hole Zimmer Periarticular Distal Femoral Locking plate. The patient had an uneventful recovery and his fracture was fully united when reviewed seven months post operatively (Figure 1). He was able to bear full weight with no joint line tenderness, no symptoms of pain or locking of the knee and a range of movement of 0-135°.
