Negative Pressure Wound Therapy in Infected Wound following Posterior Spinal Instrumentation using Simple Self-assembled System: A Case Report

CW Chang, MD (USM), HZ Chan, MD (USM), SW Lim, MS Ortho (UM),
EH Khoo, MS Ortho (UM), Zulkiflee O, MS Ortho (USM)

Department of Orthopaedics, Penang General Hospital, George Town, Malaysia

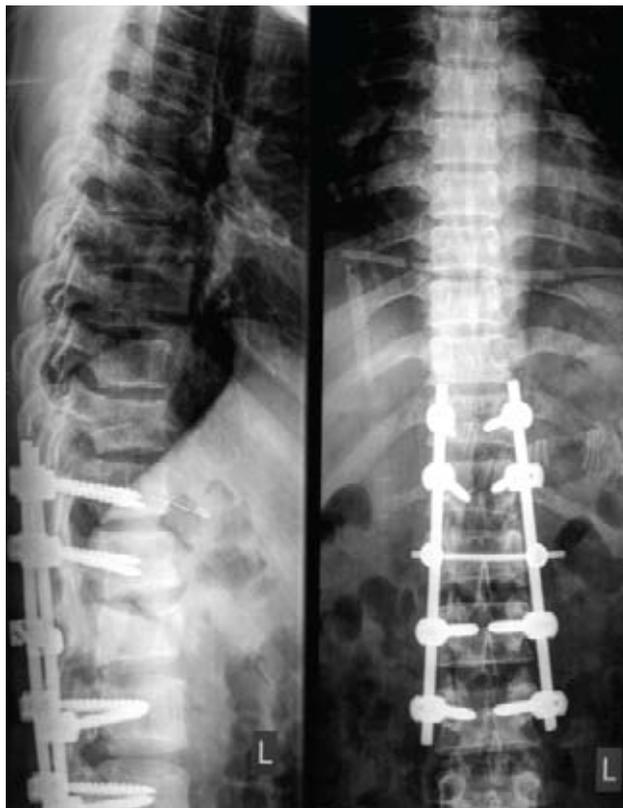
Fig. 1: Thoracolumbar radiograph of the patient after posterior instrumentation.

A 33 years old man sustained Lumbar 1 (L1) Chance fracture after a fall from 20 feet height. He underwent long segment posterior instrumentation from 11th thoracic to 3rd lumbar vertebrae (Figure 1). Unfortunately one month later, he developed deep surgical site infection. Wound debridement was done and he was started on ceftriaxone. The implant became exposed after the debridement (figure 2A).

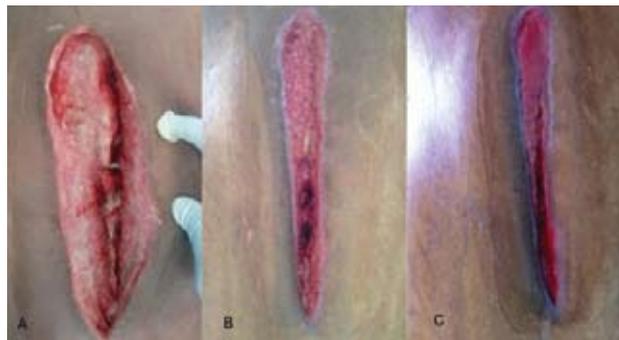
Fig. 2: A – Post debridement day one, wound was clean but implant was exposed. B – After two cycles of NPWT, the wound was partially covered with healthy granulation tissue. C - The wound was completely covered with granulation tissue and the implant was no longer visible after 12 days.

Therefore, second cycle of NPWT was started. After four days, the wound was very clean and granulation tissue had covered the implant partially (Figure 2B). He was given a third cycle of NPWT for another four days. The wound was completely covered with granulation tissue and the implant was no longer visible after 12 days (figure 2C). He was discharged home after three weeks. On subsequent follow up of the patient as an outpatient, the wound had healed completely without sinus formation or pus discharge.

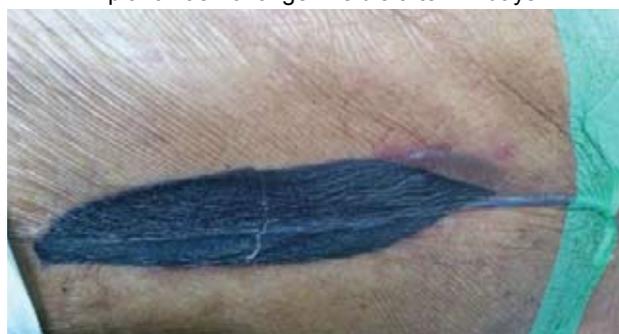
Fig. 3: Self-assembled NPWT system.

Post- debridement Day 1, the wound was healthy and free from necrotic debris. NPWT was applied using a simple self-assembled system. Two layers of open cell foam sponge were cut into the shape of the wound bed and suction tubing was laid in between the sponge layers. The wound was then sealed with occlusive film dressing (Figure 3). The tubing was connected to a suction canister with a pressure of 100-125 mmHg. After four days, the wound was clean and granulation tissue started growing. However the implant was still exposed. Culture and sensitivity grew Extended-spectrum beta-lactamase (ESBL) positive *E. coli* and antibiotic treatment was changed to imipenem and fusidic acid. Removal of implant was imminent but the patient refused.

by four times with an additional 58 days of hospital stay ². Besides surgical debridement and antibiotic treatment, wound care is an important and major factor in overall recovery. The NPWT used in this study consisted of a wall suction unit with a disposable canister and sponge with a suction tube. This self-assembled NPWT system is less expensive compared to the commercially available system. Conventional wound care using daily saline gauze dressing or colloid gel dressing is very labour intensive. The NPWT on the contrary requires only biweekly change.
