# Intra-Articular Migration Of Broken Patella Cerclage Wire And Its Arthroscopic Retrieval: A Case Report

Department Of Orthopaedic And Traumatology, Hospital Tengku Ampuan Rahimah, Selangor

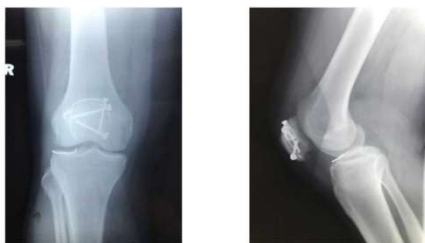
Figure 1: Plain Radiography of AP and lateral view Right Knee.

A 36 years old male was referred for right knee pain for the past one month. Patient sustained right patella fracture due to motor-vehicle accident 15 years ago, which was operated. Currently patient denied recent trauma, locking or instability symptoms. Clinical examination revealed no significant findings with full range of motion. There were no physical signs of infection with well healed midline scar. Further radiographic examination of the right knee showed the 3 cancellous screws in situ, with a broken cerclage wire fragment migrated intra-articularly (Fig. 1). The patient was electively admitted for removal of implant. The broken wire fragment was identified under the anterior horn of lateral meniscus and retrieved in one piece arthroscopically (Fig. 2). Other implants removed with open method.
