RECON PLATING OF GREATER TROCHANTERIC FRACTURE: IS IT TOO MUCH?

Ab Aziz MA, Abdul Aziz MS, Mohd Noor F, Ibrahim MF, Mustapha MF

Department of Orthopaedic, Hospital Tengku Ampuan Najihah, Kuala Pilah, Negeri Sembilan.

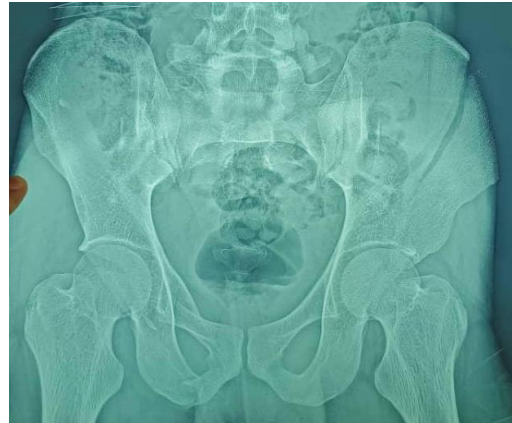
Figure 1: Pre-operative radiograph

A 28 years old male, alleged motor vehicle accident and complain of pain of bilateral hip & left waist. On examination, tenderness & reduced range of motion of bilateral hip. Distal pulses palpable and good circulation. Plain radiograph showed fracture of right acetabulum & left iliac wing.
