## Miss-A-Nail Technique It Is Easier Said Than Done

Murugun Y; Tokiran MF; Nazri MN  
Hospital Segamat, KM6, Jalan Genuang, 85000, Segamat Johor.

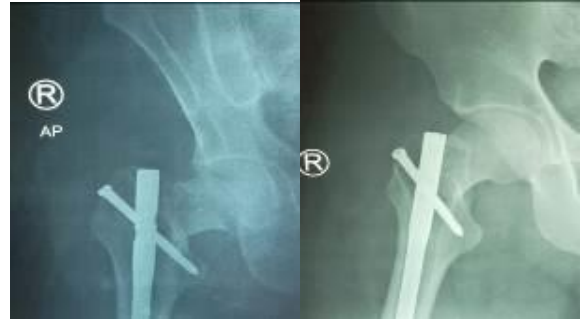
**Figure 1: AP and Lateral view right hip post targon nail complicated with neck of femur fracture.**

A 37-year old male with no known medical illness involved in an alleged motor-vehicle accident. Post trauma patient was diagnosed with close comminuted fracture midshaft right femur. Fracture was fixed with a targon nail and complicated with an iatrogenic neck of femur fracture. From the literature, there are few methods to manage this iatrogenic femoral neck fracture and Miss-A-Nail Technique is one of them.

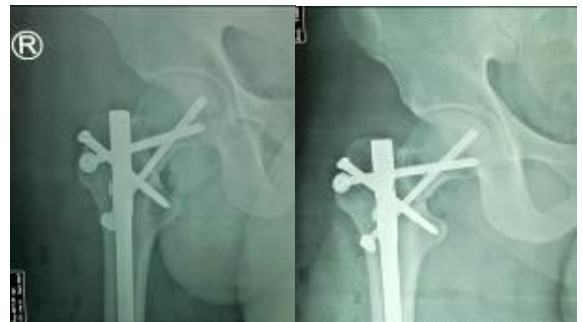
**Figure 2: AP view right hip post screw fixation of neck of femur.**

Intraoperative difficulties in using this technique include the small window through which the screw can be passed over the preexisting targon nail, making fixation of femoral neck difficult. The 1st screw was inserted at inferior part of the femoral neck, which is relatively easier. A 2nd screw should be inserted slightly proximal and parallel to the 1st screw to achieve better compression and rotational stability.

However the area left was very limited to insert the 2<sup>nd</sup> screw. Multiple attempts were made and failed. Therefore, we decided to insert a horizontal screw at the superior part of the neck to achieve rotational stability. Postoperatively, patient well and advised for strict non-weight bearing ambulation.
